PRINGLE BAY

# **PRINGLE BAY GRAVEL STREETS**

## **CONDITION SURVEY AND RESULTS**

AUGUST 2020  
(REV 3)

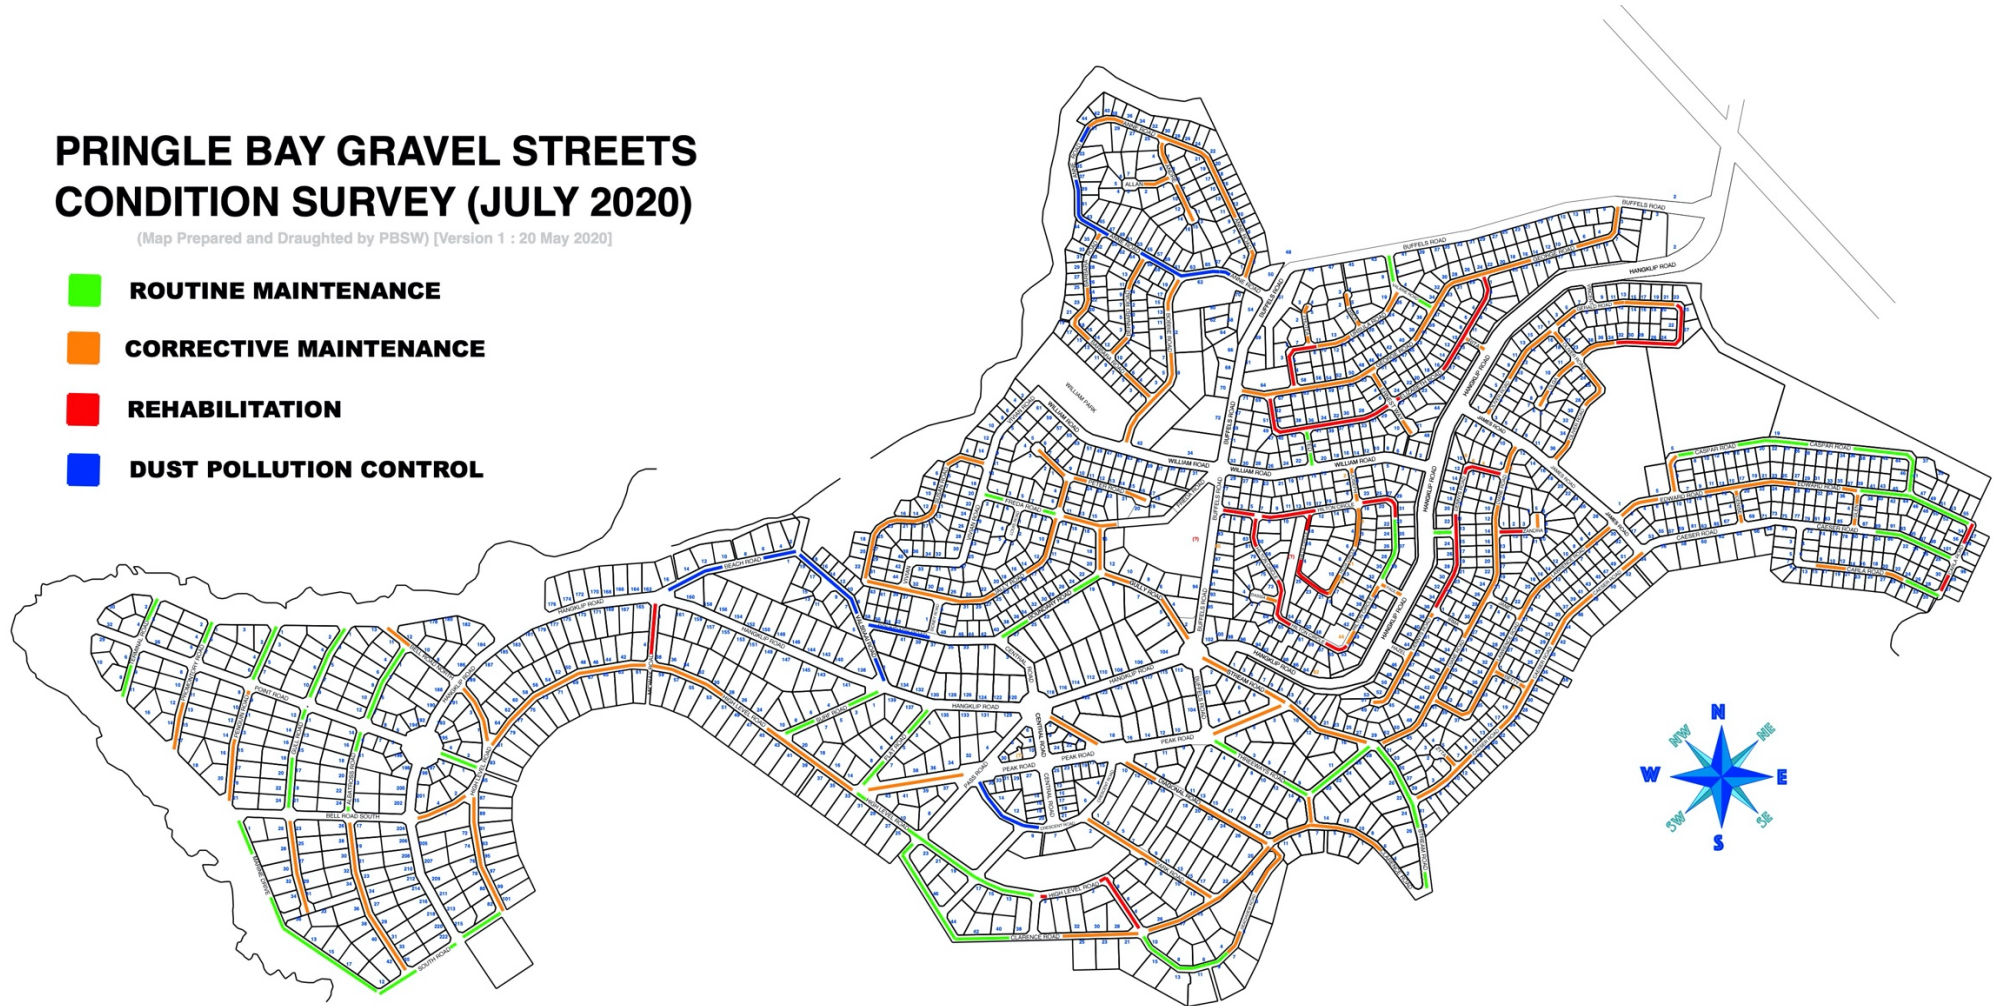
### PRINGLE BAY GRAVEL STREETS CONDITION SURVEY (JULY 2020)

MAP SHOWING MAINTENANCE REQUIREMENTS TOGETHER WITH UNFILTERED PROCESSED DATA

- **ROUTINE MAINTENANCE**
- **CORRECTIVE MAINTENANCE**
- **REHABILITATION**
- **DUST POLLUTION CONTROL**
